By Daniel Warren, Robert Church and Rick Davey, C & C Technologies, Inc., USA

Discovering H.M.S. Ark Royal

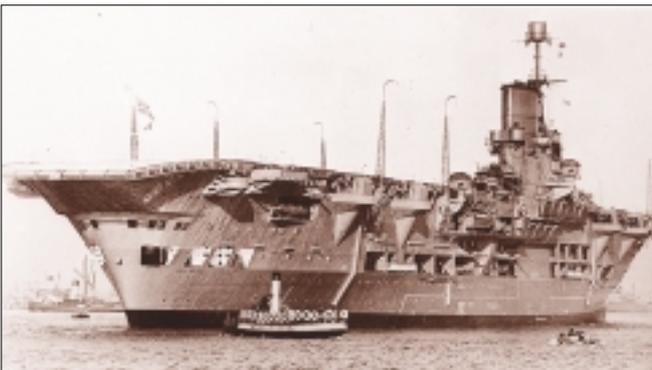
Figure 1: H.M.S. Ark Royal (Photo Naval Historical Center).

that had been converted from other types of warships, the Ark Royal had been planned from conception to be an aircraft carrier. Constructed in Birkenhead, England, between 1935 and 1938, the new carrier had an overall length of 244 metres and displaced over 23,000 tons when it was commissioned in November 1938. It was capable of speeds of up to 31 knots and could carry up to seventy-two attack aircraft. In addition to its complement of aircraft, the Ark Royal bristled with an array of defensive armament that included sixteen 4.5-inch guns, thirty-two 2-pounder anti-aircraft guns, and thirty-two 5-inch guns. Once commissioned, the Ark Royal was assigned to the Royal Navy's Home Fleet. At the outbreak of hostilities with Germany in late 1939 the Ark Royal saw action almost immediately, its aircraft assisting in the sinking of the first German U-boat of the war, U-39. It also shot down the first German aircraft of the war. Throughout roughly the next year and a half, from October 1939 to March 1941, the Ark Royal took part in many of the major operations in the Atlantic and Mediterranean. Among these were the search for the German Pocket Battleship Graf Spree, the Norway Campaign and the destruction of the French Fleet at Dakar. In May 1941 the Ark Royal played a key role in the destruction of the German Battleship DKM Bismarck when a torpedo from one of its Swordfish aircraft severely damaged the battleship's steering.

The Ark Royal (Figure 1) was the Royal Navy's first modern aircraft carrier. Unlike other carriers in the Fleet

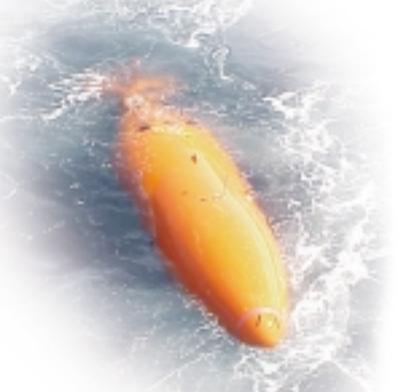
Figure 2: HUGIN 3000 AUV, (Photo C & C Technologies).

The C & C HUGIN (High Precision Untethered Geosurvey and Inspection System) Autonomous Underwater Vehicle (AUV) (Figure 2) is a third-generation AUV by Kongsberg Simrad and the first commercially operated AUV capable of surveying to 3,000 metres water depth. This AUV is integrated with a multi-instrument survey payload consisting of a Simrad EM 2000 (200kHz) swath bathymetry system, dual-frequency Edgetech Chirp side-scan sonar (120kHz and 410kHz) and an Edgetech Chirp subbottom profiler. AUV position accuracy is accomplished using an inertial navigation system coupled with a Simrad

HiPAP (High Precision Acoustic Positioning) acoustic tracking system. Surveying in 1,500 metres of water HUGIN 3000 positioning is accurate to ± 5 metres, after post-processing.

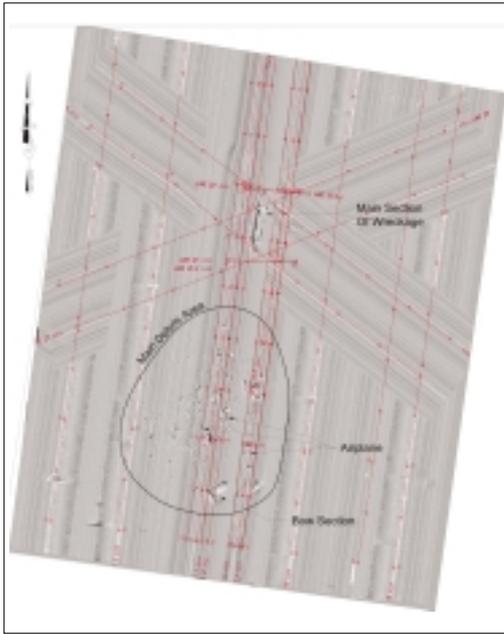
Figure 3: High-resolution side-scan sonar mosaic of Ark Royal wreck site (Image by BBC and C & C).

The sonar mosaic (Figure 3) provides an overall picture of the wreck remains. It indicates that the wreck site is strewn over nearly 0.27 square kilometres of seafloor and is oriented roughly north to south. At the northern edge of the wreck site are the remnants of the main hull. Approximately 218 metres to the south of

Lying south of the main hull by 218 metres is a 527-metre long by 426-metre wide field of debris (Figure 3). High-resolution side-scan imagery depicted a wide variety of objects scattered throughout this area, including pieces of the superstructure, flight deck remains, gun turrets and several aircraft. One of the aircraft would seem to be an inverted Fairey Sword-

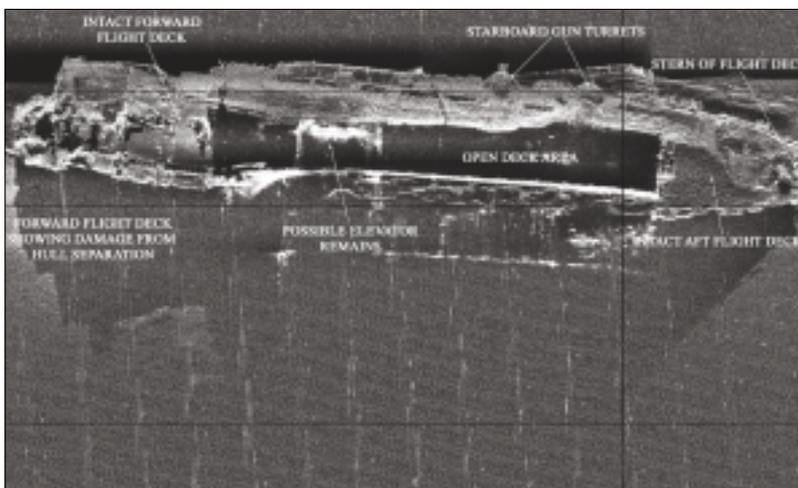
Figure 4: High-resolution side-scan sonar image of main hull of Ark Royal (Image by BBC and C & C).

The main hull section measures 183 metres in length, roughly 61 metres shorter than the recorded length of the Ark Royal. The high-resolution side-scan sonar images of the main hull (Figure 4) revealed extensive damage to the forward section, suggesting that a portion of the bow had ripped away, along with portions of the flight deck and the superstructure. Several of the Ark Royal's gun turrets remain intact on the wreck and are visible in the high-resolution imagery. A multi-beam composite of the hull remains (Figure 5) shows the vessel sitting relatively upright, with only 10 metres of bottom relief, indicating that much of the lower hull is embedded in the seafloor. Displaced sed-

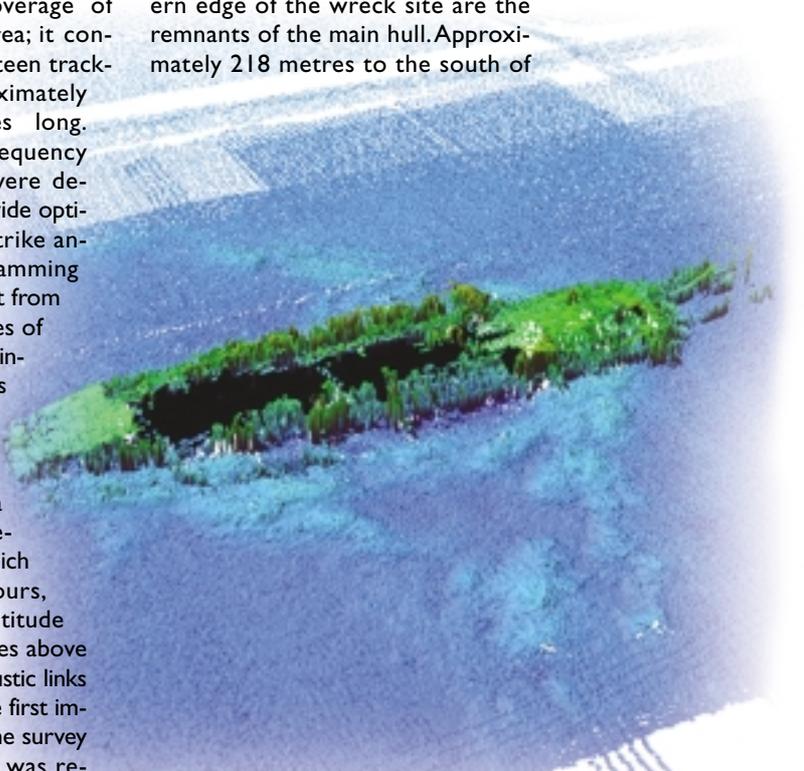
Figure 5: Multi-beam composite image of main hull of Ark Royal (Image by BBC and C & C).

iments visible in the multi-beam imagery provide evidence that the impact of the hull as it entered the seabed was in a south to north direction.

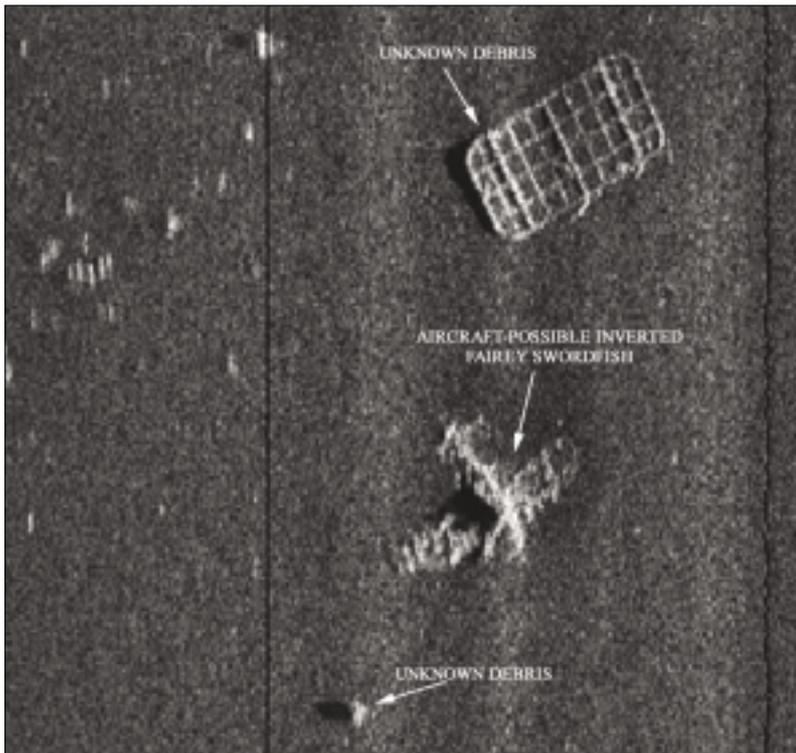
Figure 6: High-resolution side-scan sonar image of possible Swordfish aircraft in field of debris (Image by BBC and C & C).

fish biplane (Figure 6). At the southern extremity of the field is a large section of debris partially buried in the seafloor. This appears to be the remnants of the missing bow section (Figure 7) with one of the aerial lift arms still attached.

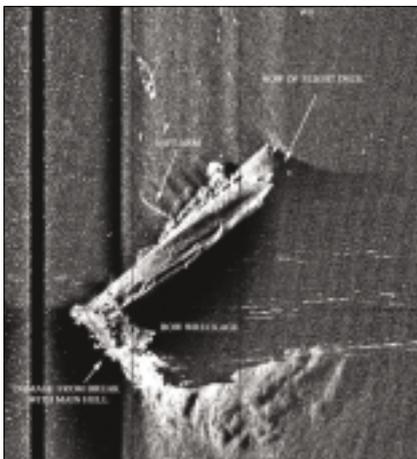
Figure 7: High-resolution side-scan sonar image of Ark Royal bow remains (Image by BBC and C & C).

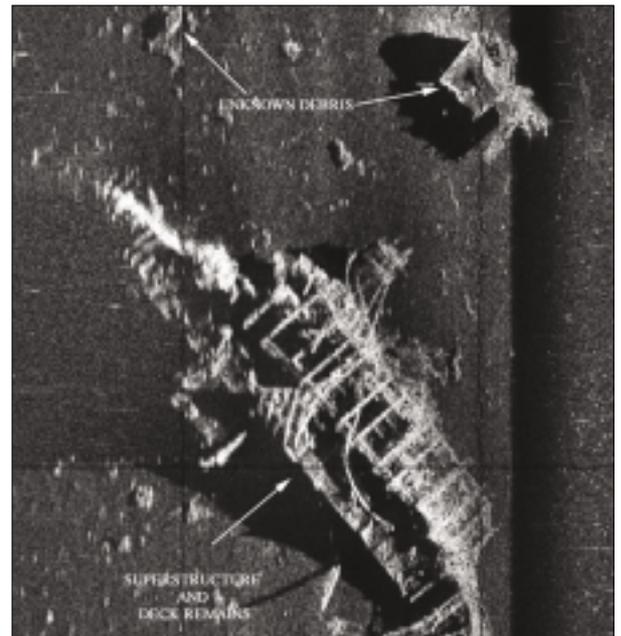
Figure 8: High-resolution sonar image of remains of Ark Royal superstructure (BBC and C & C).
